Rear Bumper Paint Is Peeling

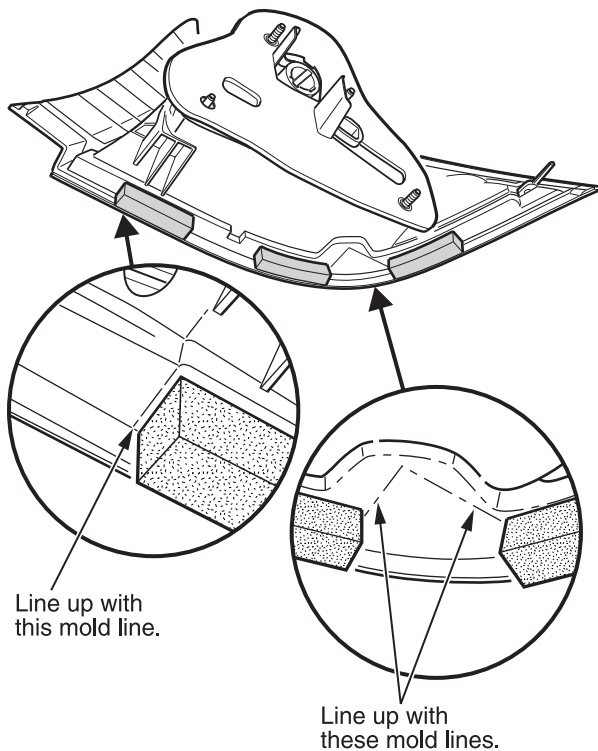
LEFT TAILLIGHT SHOWN

4. Repair the rear bumper.
 - If the paint damage on the horizontal surface is up to 10 mm long and is *not* clearly visible, use 400 grit sandpaper to scuff the surface around the affected area. Carefully apply Honda touch-up paint to the area, then hold a heat gun over it for 5 minutes to dry the paint. Be careful not to bubble or blister the paint.
 - If the paint damage on the horizontal surface is to a customer's vehicle, or it is more than 10 mm long and is clearly visible, remove the rear bumper (see section 20 of the 2001–02 Civic Shop Manual), and have the body shop repaint it.
5. Use a mild solution of detergent and water to clean the bottom lip of both taillight lenses.
6. Mount three foam blocks to the bottom lip of each lens. Use the mold lines on the lip as a reference.

7. Reinstall the rear bumper (if removed). Reinstall the taillights. Adjust the taillights upward, then torque the mounting nuts to 5 N·m (4 lb-ft). If the taillights are hard to install, the foam blocks are probably hitting one of the tabs on the bumper. Find out where the foam is making contact, and trim the foam as needed.
8. Plug in the taillight connectors.
9. Reinstall the trunk side trim panels.
