FACTORS CONTRIBUTING TO LANDSLIDE
ACTIVITY IN THE WINTER OF 1995-96,
CLEARWATER COUNTY NEAR OROFINO, IDAHO

A Thesis
Presented to
The Graduate Faculty
Central Washington University

In Partial Fulfillment
of the Requirements for the Degree
Master of Science
Geology

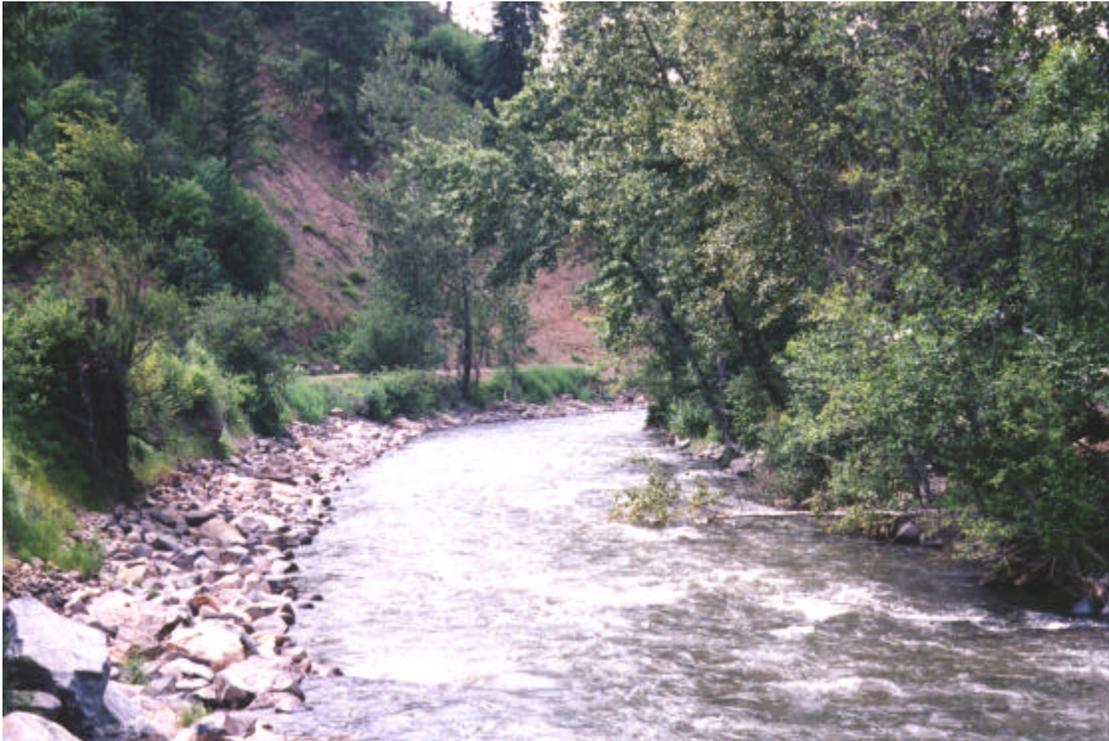
Figure 11: Photograph showing landslide site 23. (Notice mitigation of stream channel.)

The landslide at this site is relatively large with an estimated volume of over 600 cubic feet of displaced material. Orofino Creek flows at the base of this landslide (Figure 11). The landslide that initiated at this site is on a NE facing slope. The landform here is on a slope hollow. Steepness is more than 40-45%. There are natural springs approximately 5 feet from the top of the landslide.

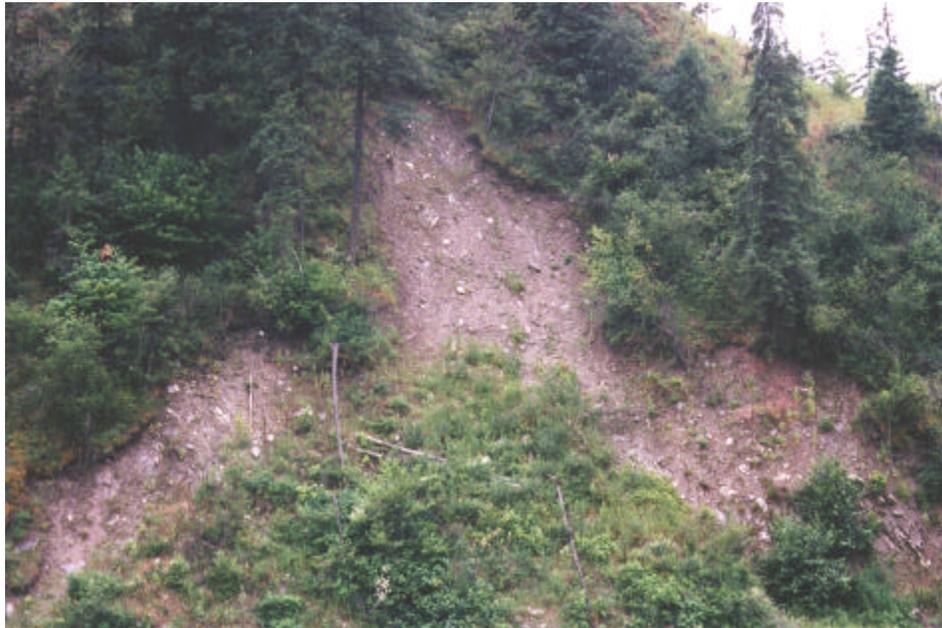
Figure 13: Photograph of landslide at site 26.

The landslide at this site is relatively large with an estimated volume of over 400 cubic feet of displaced material. Orofino Creek flows at the base of this landslide (Figure

13). The landslide that initiated at this site is on an ENE facing slope. The landform here is on a slope hollow. Steepness is more than 50%. There are natural springs approximately 5 feet from the top of the landslide.

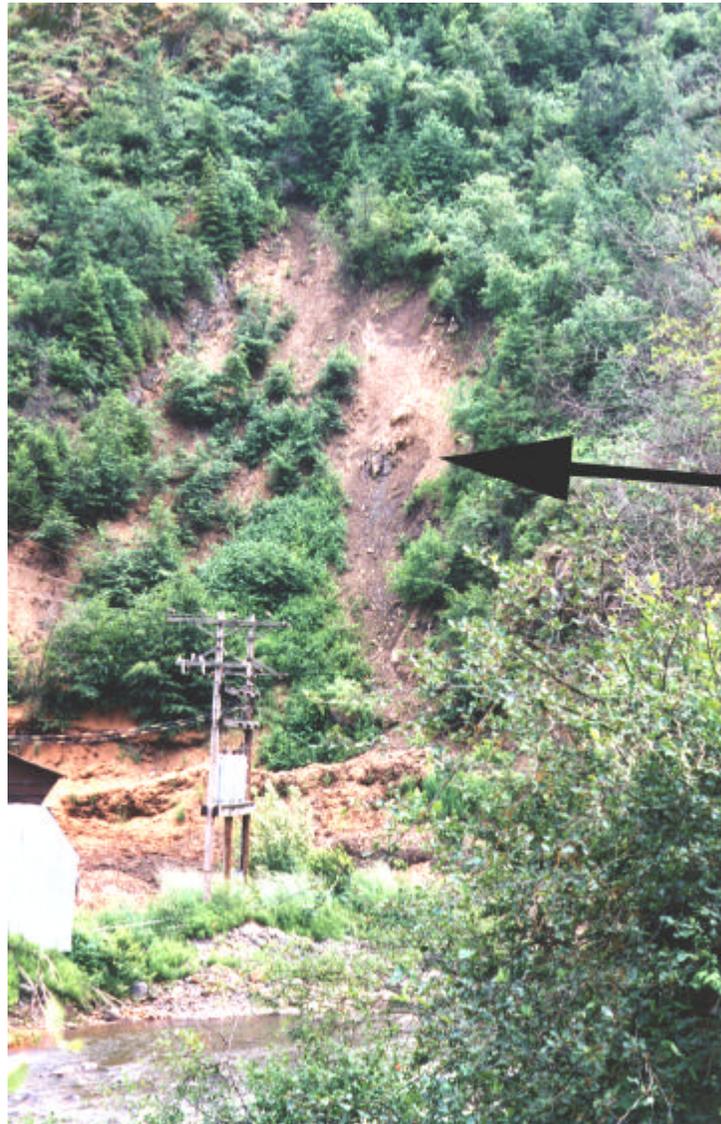
Figure 14: Photograph of landslide at site 27. Arrow indicates location of springs.

The landslide at this site is relatively large with an estimated volume of over 600 cubic feet of displaced material. Orofino Creek flows at the base of this landslide (Figure 14). The landslide that initiated at this site is on a NNE facing slope. The landform here is on a slope hollow. Steepness is more than 50%. There are natural springs approximately 5 feet from the top of the landslide.

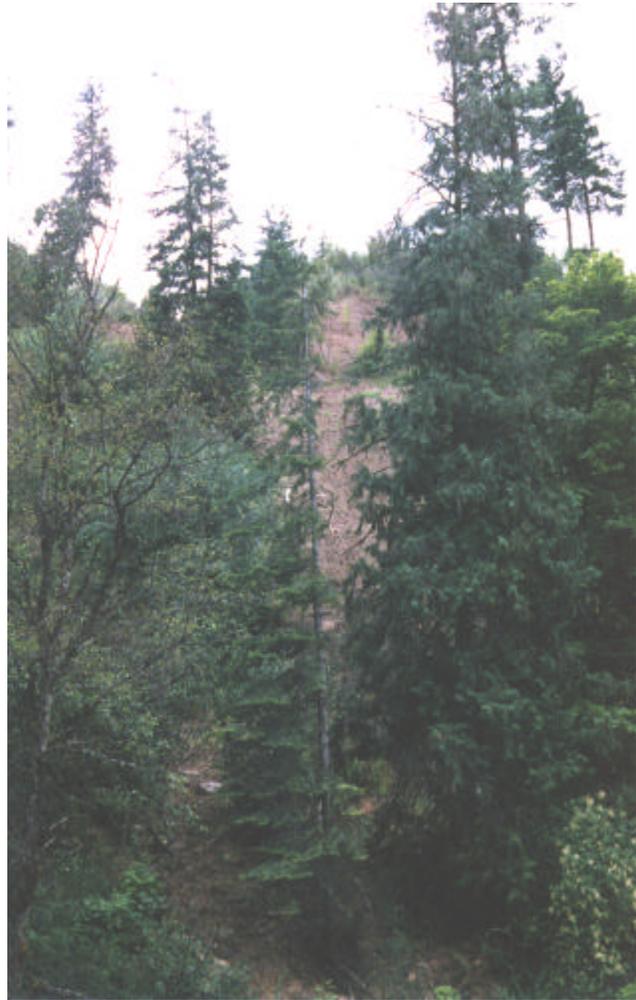
Figure 15: Photograph of landslide at site 28.

The landslide at this site is relatively large with an estimated volume of over 1100 cubic feet of displaced material. Orofino Creek flows at the base of this landslide (Figure 15). The landslide that initiated at this site is on a NW facing slope. The landform here is on a slope hollow. Steepness is more than 50%. There are natural springs approximately 5 feet from the top of the landslide.

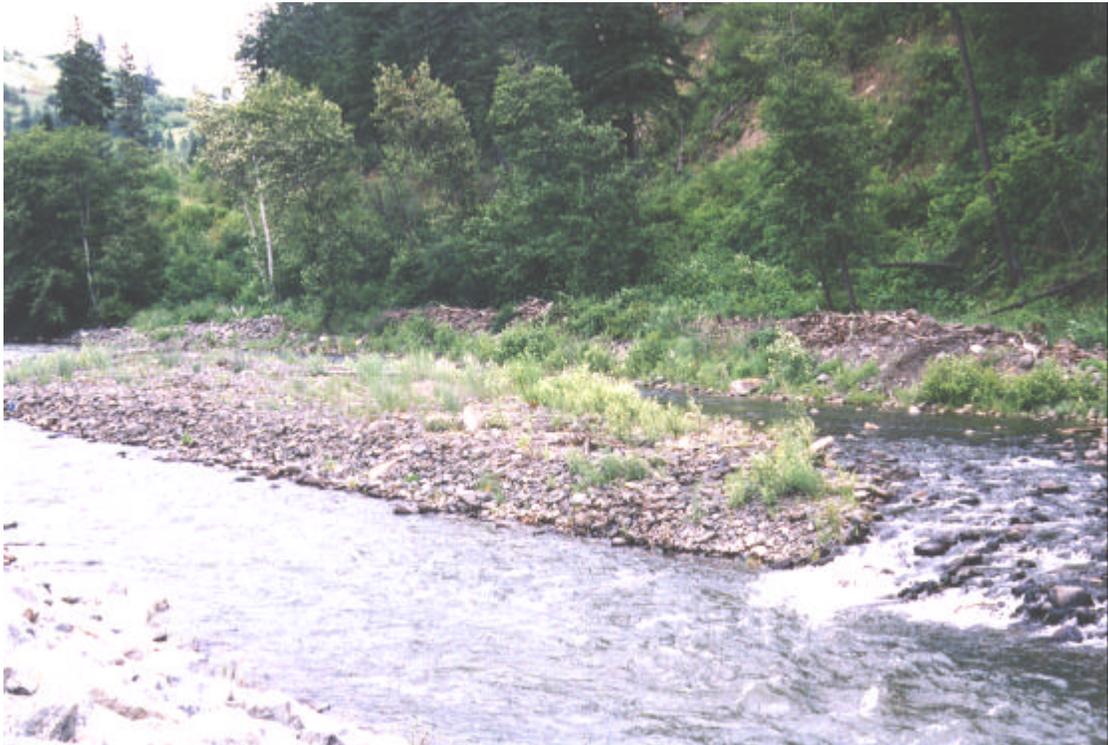
Figure 16: Photograph of debris levee formed from displaced material. Landslide site 30 in background (center).

The landslide at this site is relatively large with an estimated volume of over 800 cubic feet of displaced material. Orofino Creek flows at the base of this landslide (Figure

16). The landslide that initiated at this site is on a NW facing slope. The landform here is on a slope hollow. Steepness is more than 50%. There are natural springs approximately 5 feet from the top of the landslide.

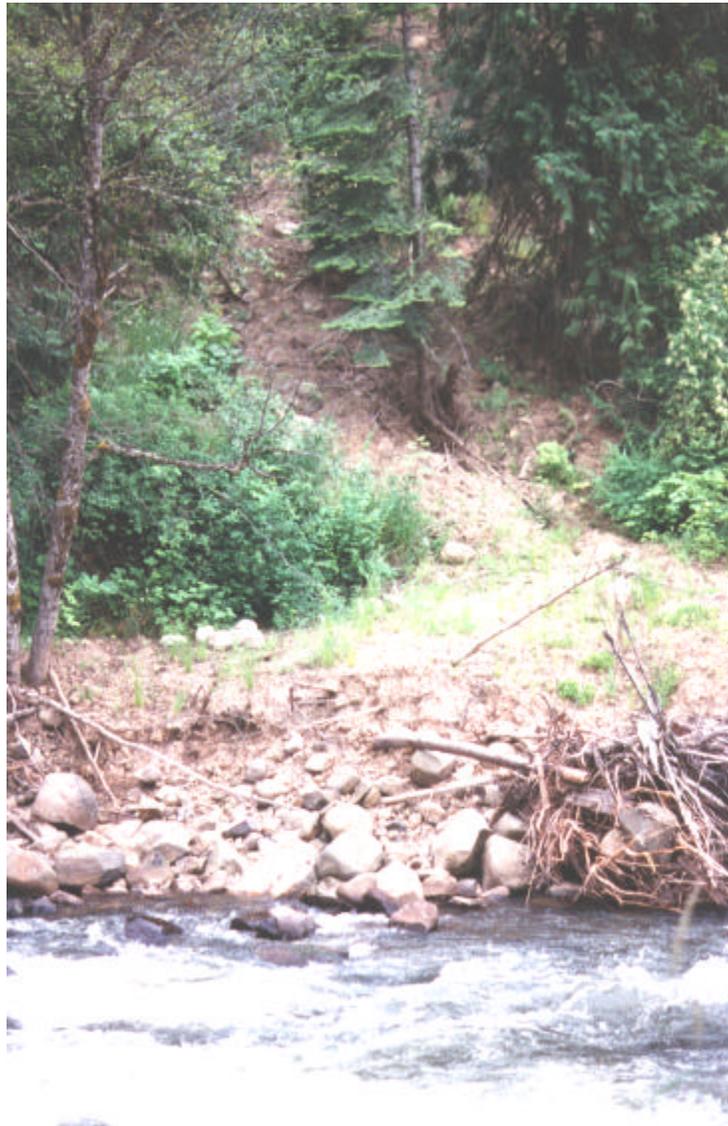
Figure 17: Photograph of Landslide at site 31.

The landslide at this site is relatively large with an estimated volume of over 600 cubic feet of displaced material. Orofino Creek flows at the base of this landslide (Figure 17). The landslide that initiated at this site is on a north-facing slope. The landform here is on a slope hollow. Steepness is more than 50%. There are natural springs approximately 5 feet from the top of the landslide.

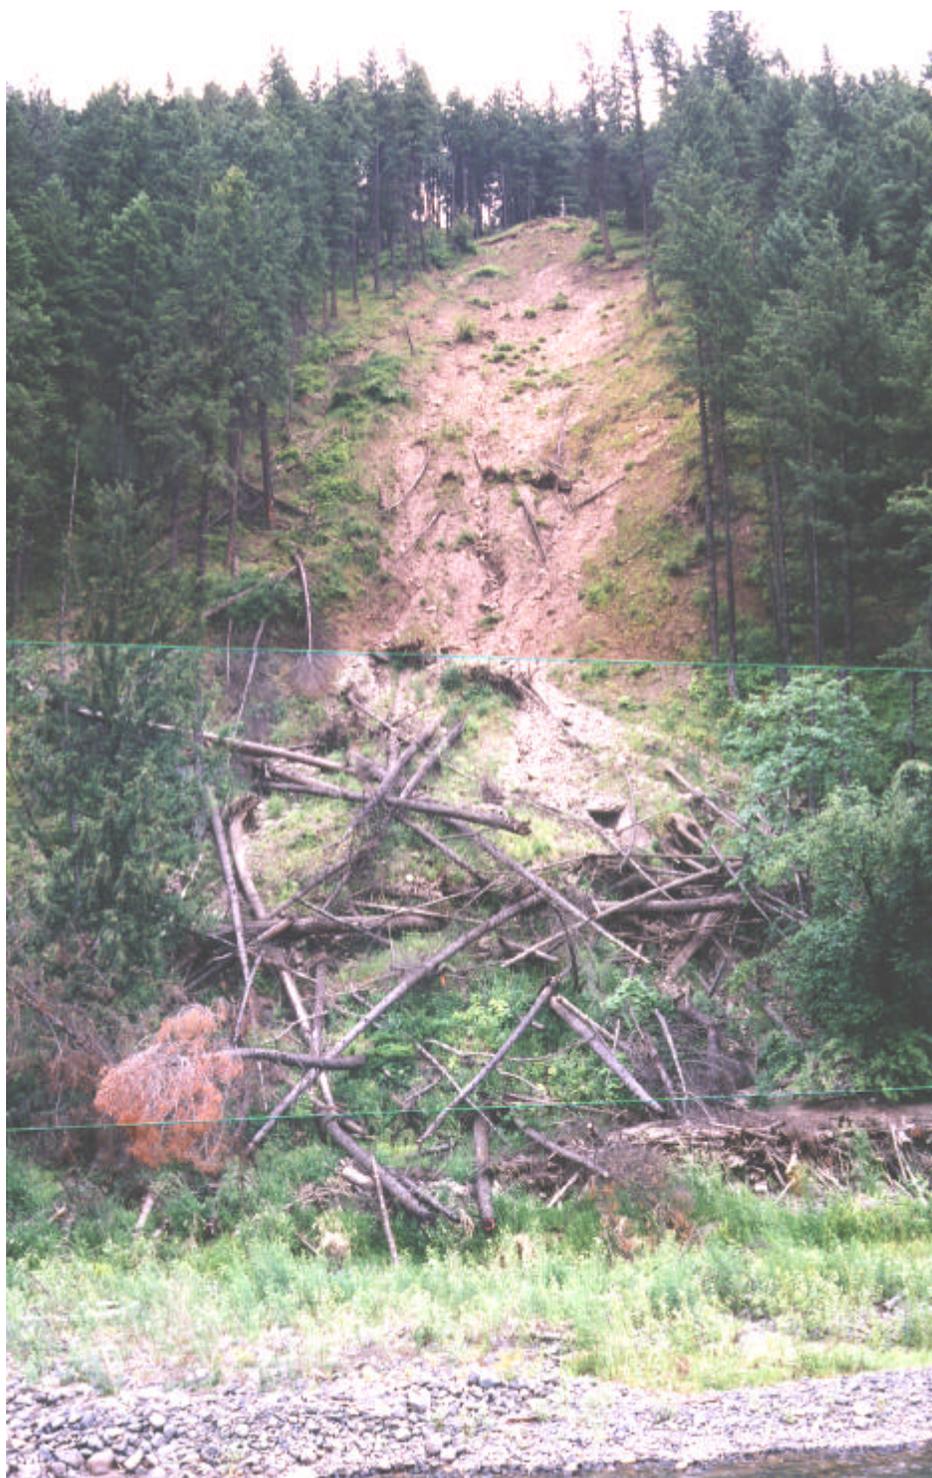
Figure 18: Photograph of Landslide at site 32. Notice pile of mixed debris at bottom of slope.

The landslide at this site is relatively large with an estimated volume of over 700 cubic feet of displaced material. Orofino Creek flows at the base of this landslide (Figure 18). The landslide that initiated at this site is on a north-facing slope. The landform here is on a slope hollow. Steepness is more than 50%. There are natural springs approximately 5 feet from the top of the landslide.
